Subject: EPA Inspection Report

**CWA COMPLIANCE EVALUATION INSPECTION REPORT
U.S. ENVIRONMENTAL PROTECTION AGENCY, REGION 5**

Compliance Evaluation Sampling Inspection

FOIA Ex. 6
(Personal) Farms, LLC
FOIA Ex. 6 (Personal Privacy)

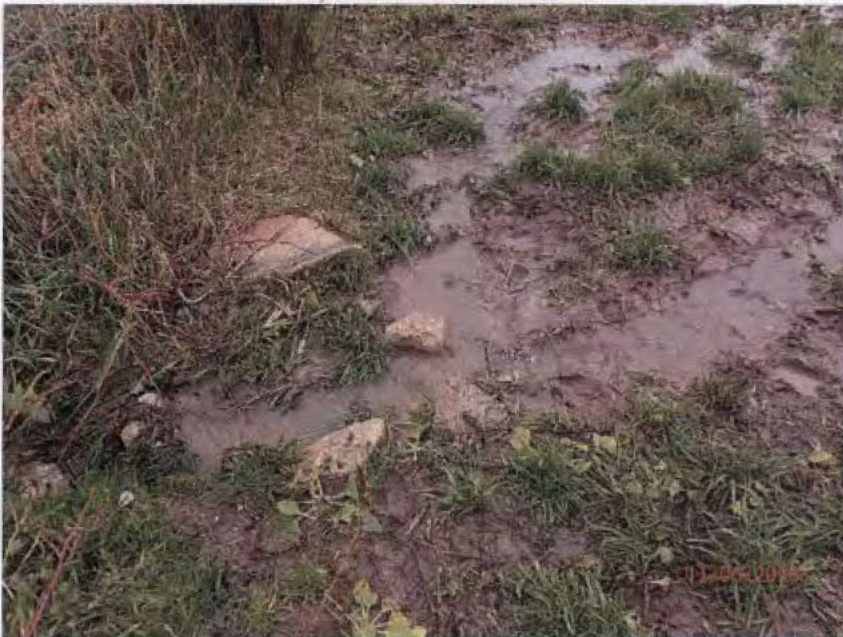
75: PB060077

Description: Discharge pathway flowed down the embankment to the intermittent unnamed tributary.

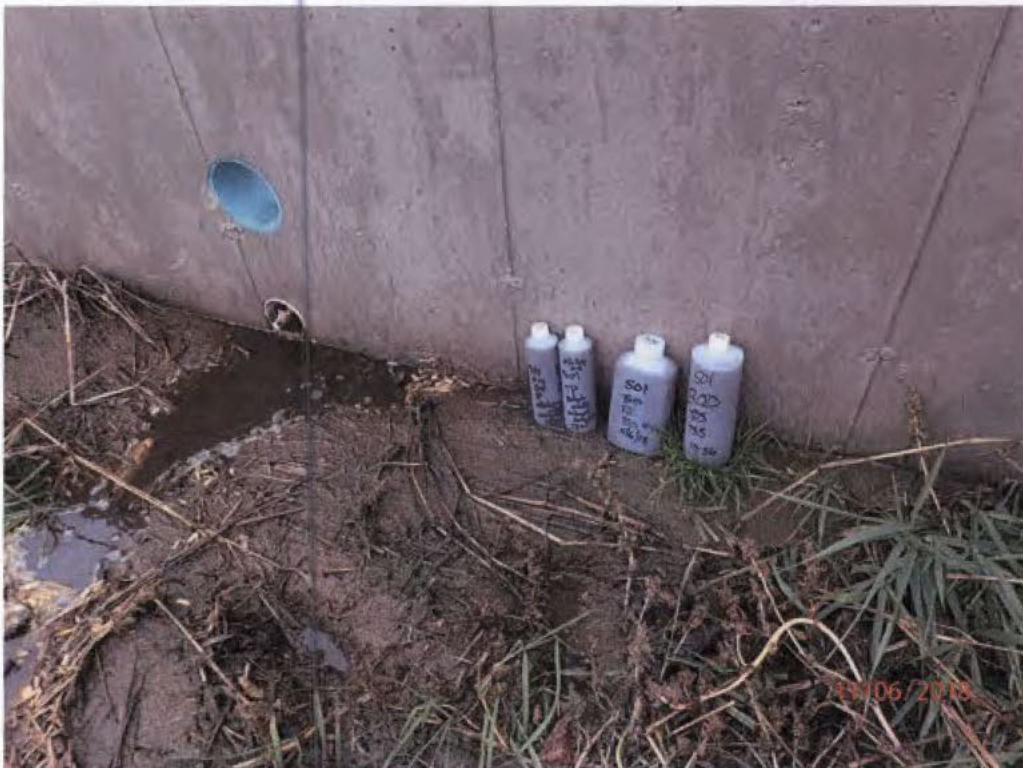
76: PB060079

EPA then took two samples (S01 and S02) of the flow from the concrete lots by the Heifer and Steer Barns. The first sample was from the liquid on the east side of the concrete wall that had flowed out of the weep hole. The second sample was from the discharge pathway at the confluence of the discharge pathway and the intermittent unnamed tributary.

Description: Sample S01, named "Weephole Discharge" was taken at 10:56 A.M. from the flow out of the weep hole in the concrete wall south of the Heifer Barn. Split samples were taken for the facility.

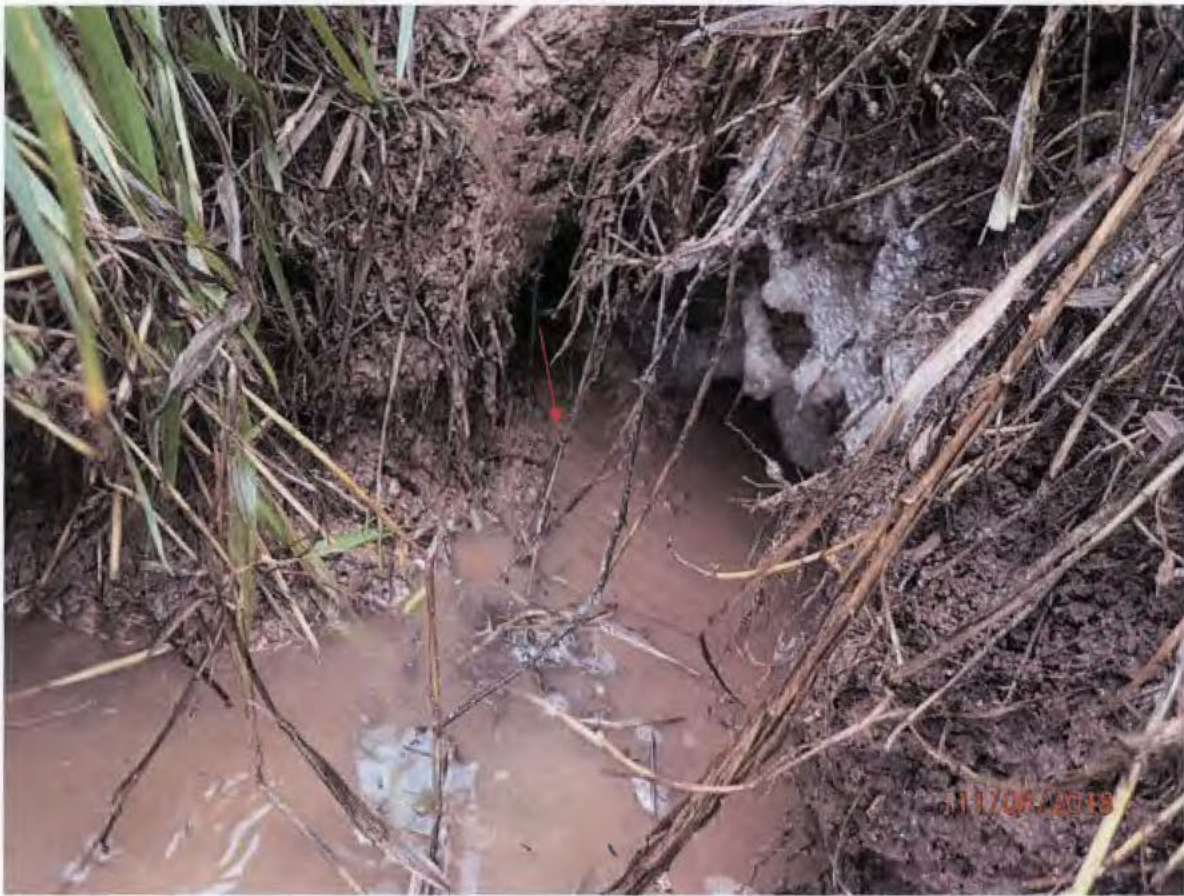
77: PB060080

Description: EPA documented the confluence of the discharge pathway from the weep hole to the intermittent unnamed tributary. The bank was undercut and foam was present at the outlet. A red arrow depicts the direction of flow from the discharge pathway to the intermittent unnamed tributary. EPA named this Confluence #1

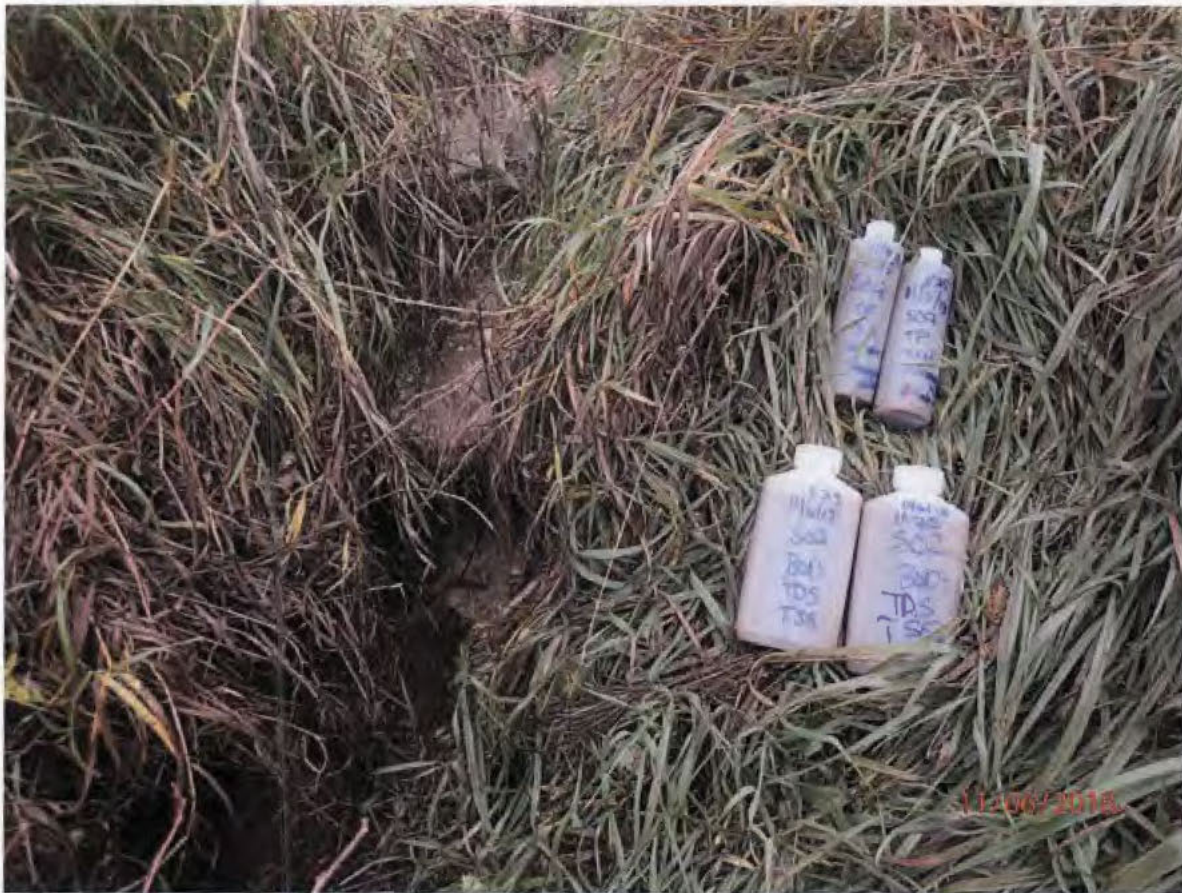
78: PB060082

Description: Sample S02, named "Confluence #1", was taken at 11:25 A.M from the confluence of the discharge pathway from the weep hole in the concrete wall and the intermittent unnamed tributary. Split samples were taken for the facility.

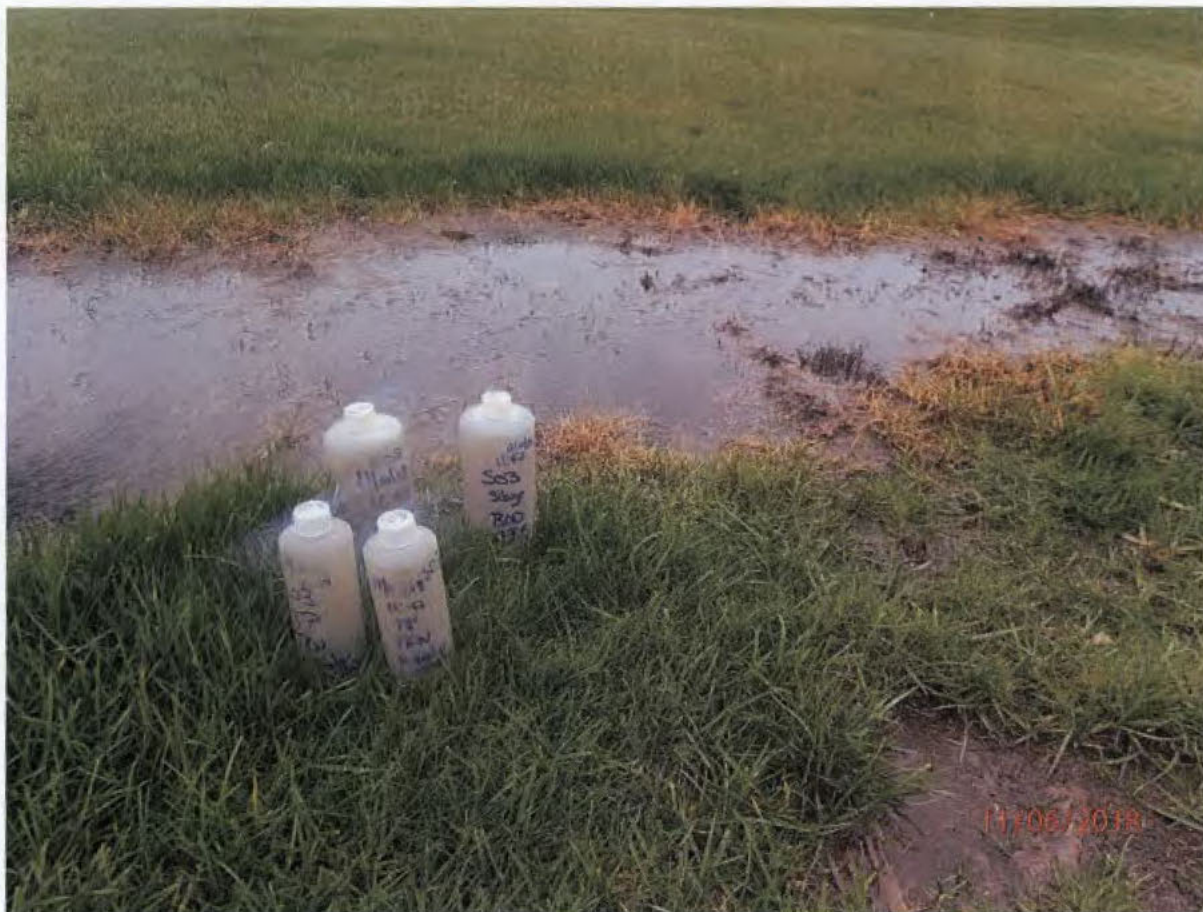
79: PB060083

EPA then walked to the front of the facility and took a sample (S03) from the pool of liquid on the west side of the silage bags. The liquid had a very strong unpleasant odor. This liquid could flow to the west through a culvert under the facility driveway and to a storm water inlet.

Description: Sample S03, named "Silage Puddle (Front)", was taken at 11:45 A.M. from the black liquid in the puddle west of the silage bags along Sandy Bay Road. There was a very strong, foul odor from this liquid. Split samples were taken for the facility.

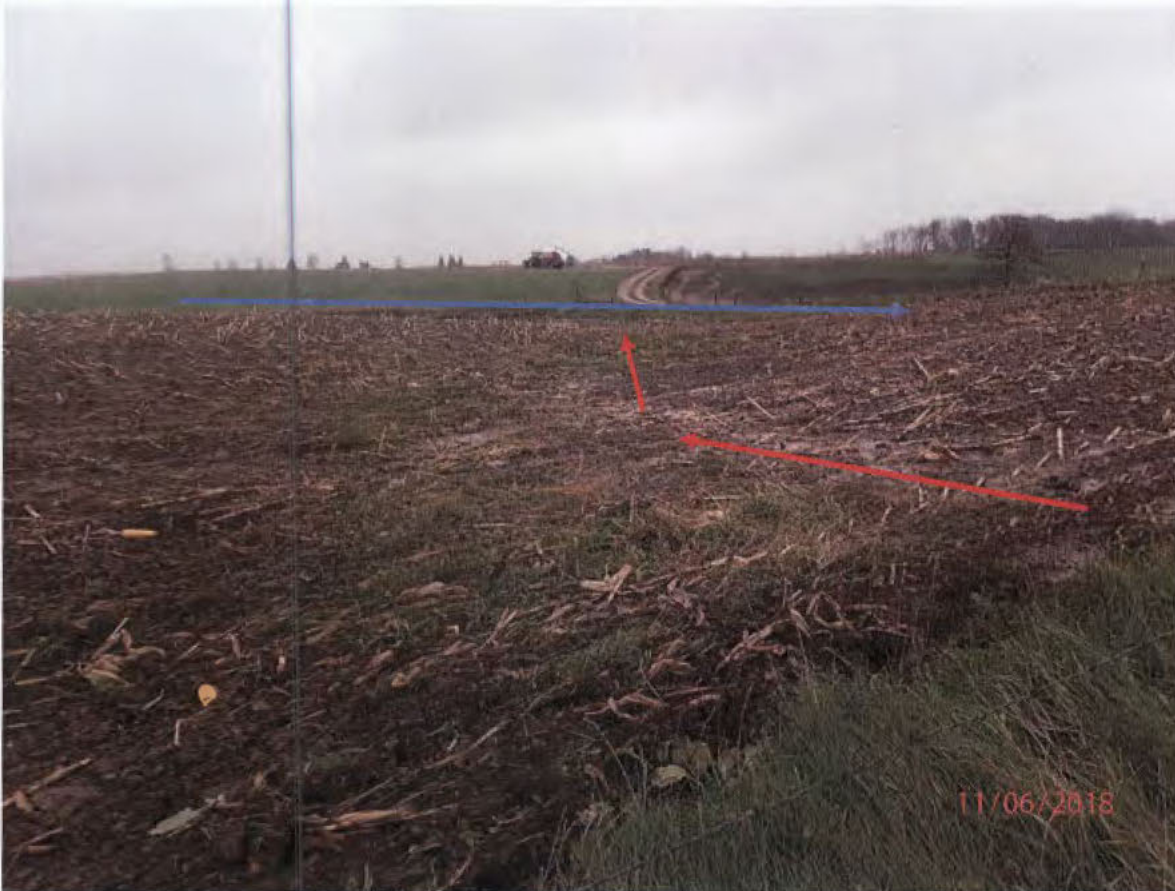
80: PB060084

EPA then walked between the Manure Pond and the Machine Shed to take a photo of the pathway that runoff from the silage bags and open pen of the Open Front Heifer Barn would take to reach the intermittent unnamed tributary. With precipitation, runoff from these two sources would combine into one flow pathway and flow downhill, to the north, and to an ag field. The flow pathway would then go through a low area in the ag field to the intermittent unnamed tributary. The distance through the ag field was approximately 250 feet.

Description: Red arrows in photo depict the pathway that manure and process wastewater from the combined flow from the open pen of the Open Front Heifer Barn and the silage bags west of the Open Front Heifer Barn would take to reach the intermittent unnamed tributary. The location of the intermittent unnamed tributary is depicted by a blue arrow.

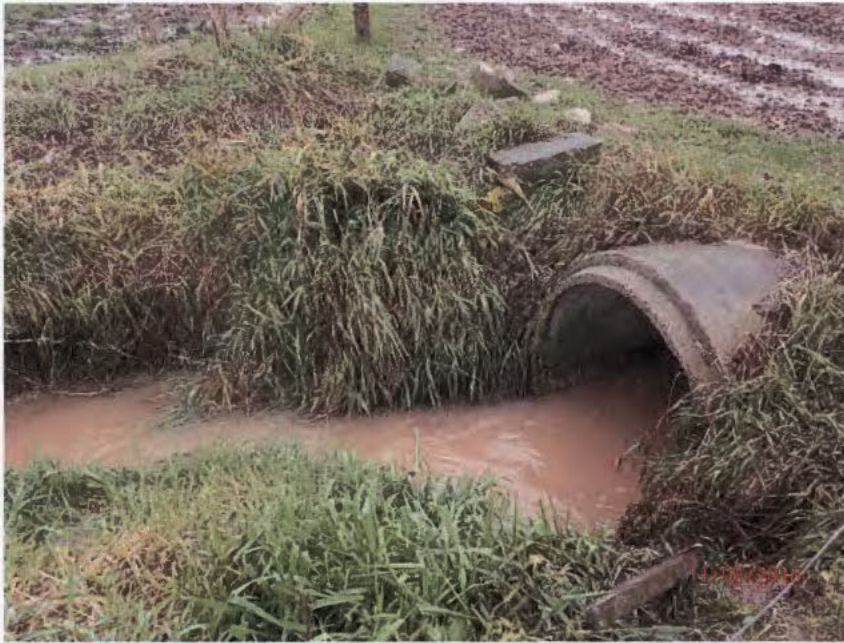
81: PB060085

Description: Culvert inlet for the intermittent unnamed tributary under the Cattle Walkway and facility driveway.

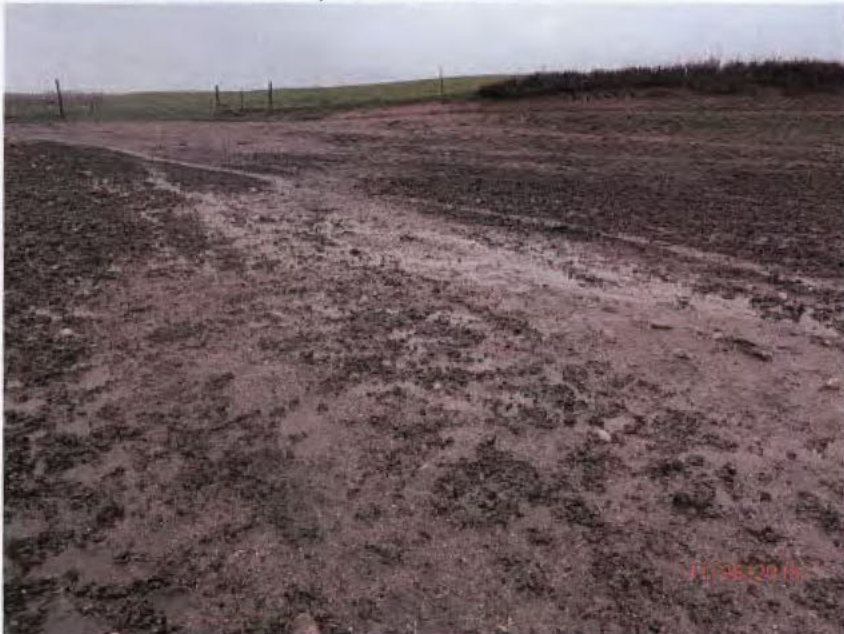
82: PB060086

EPA then walked east along the southern fence line of the Feedlot. The intermittent unnamed tributary was located just a few feet south of the fence line and the Feedlot was denuded all the way up to the fence line. EPA observed a channel of water along the fence line flowing to the east and eventually it flowed under the fence and to the intermittent unnamed tributary.

Description: Feedlot is completely denuded of vegetation.

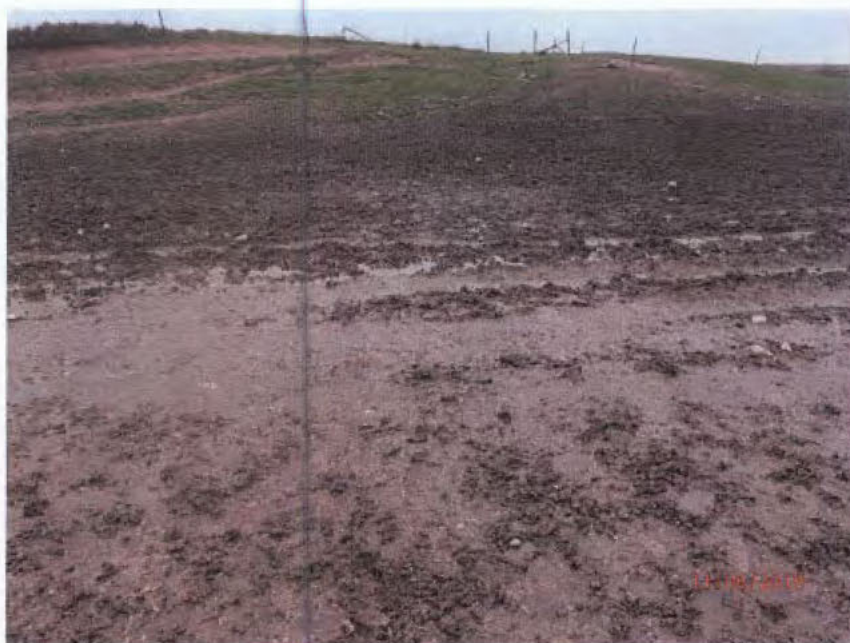
83: PB060087

Description: Feedlot is completely denuded of vegetation.

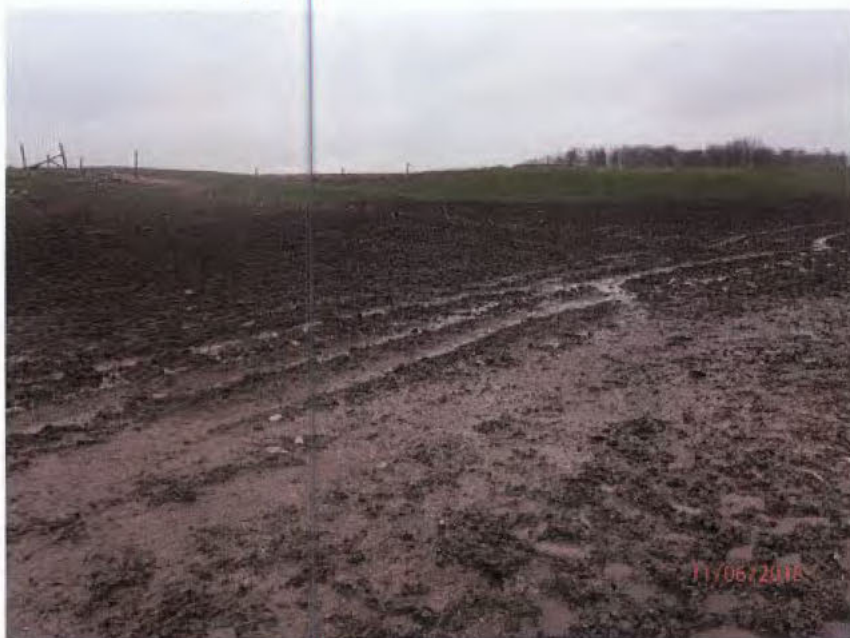
84: PB060088

Description: Feedlot is completely denuded of vegetation.

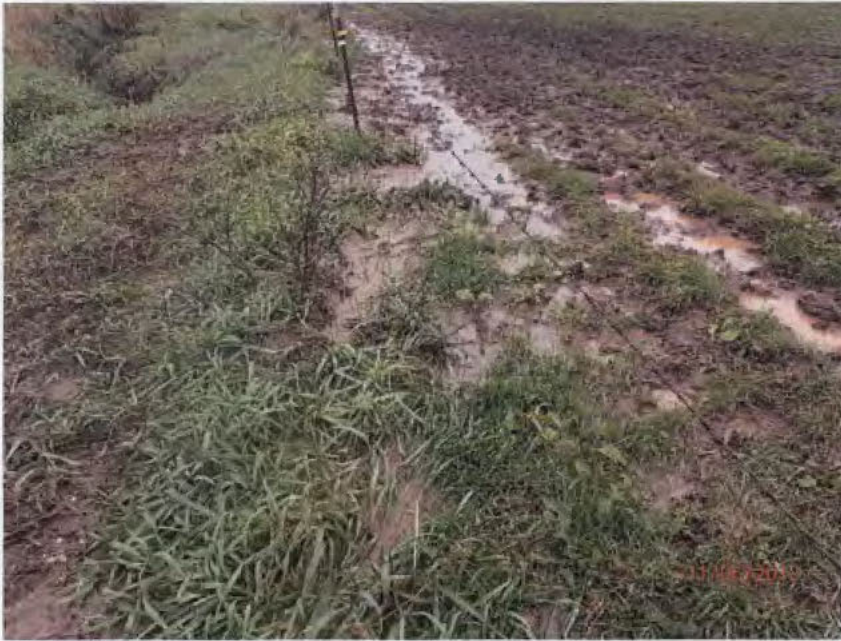
85: PB060089

Description: Discharge pathway from feedlot flows east along electric fenceline before flowing south under the fenceline and into the intermittent unnamed tributary.

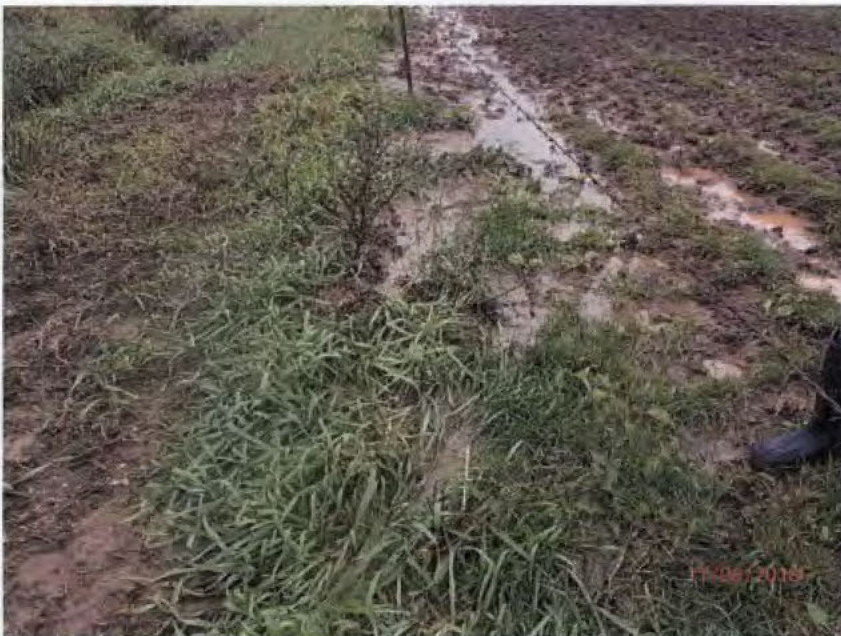
86: PB060090

Description: Flow from feedlot flows into the intermittent unnamed tributary.

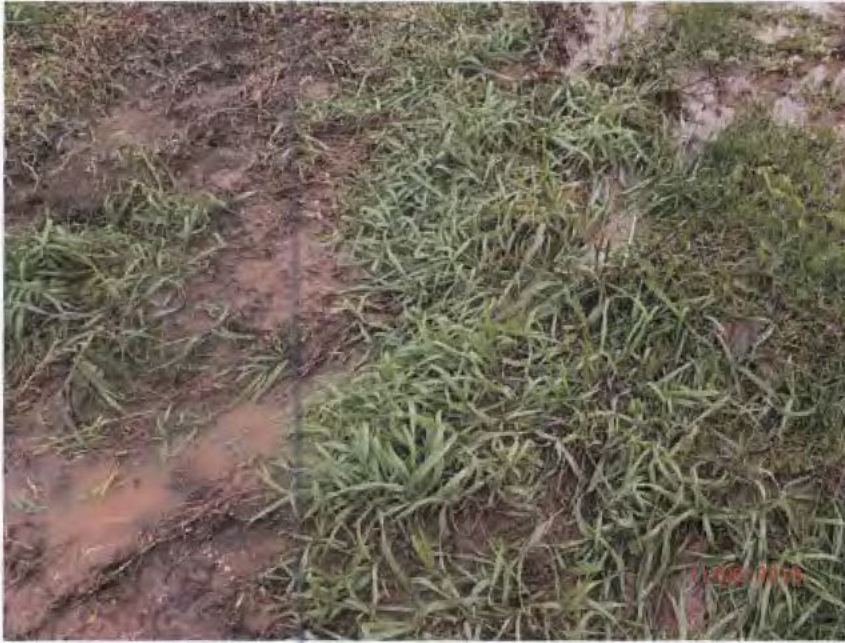
87: PB060091

Description: Flow from feedlot flows into the intermittent unnamed tributary.

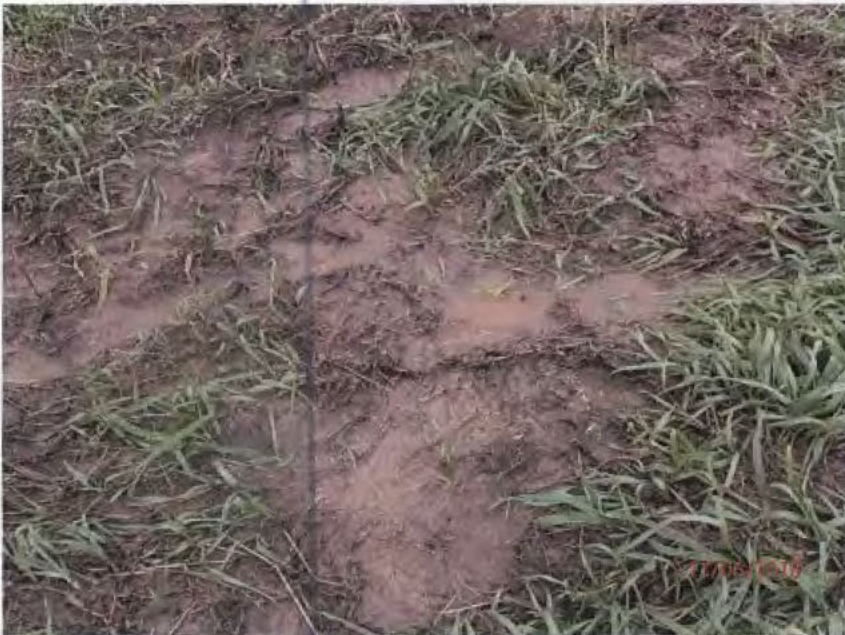
88: PB060092

Description: Flow from feedlot flows into the intermittent unnamed tributary.

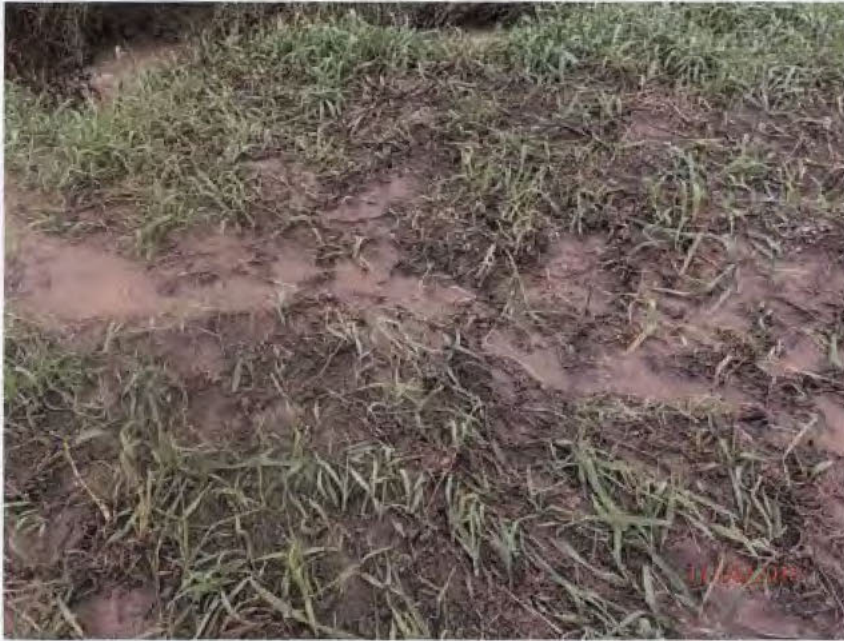
89: PB060093

Description: Flow from feedlot flows into the intermittent unnamed tributary.

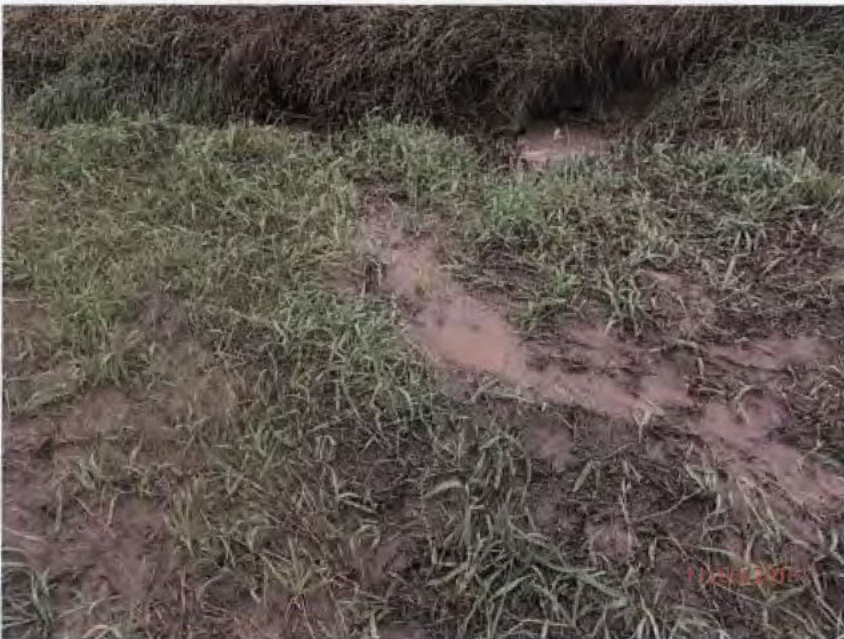
90: PB060094

Description: Flow from feedlot flows into the intermittent unnamed tributary.

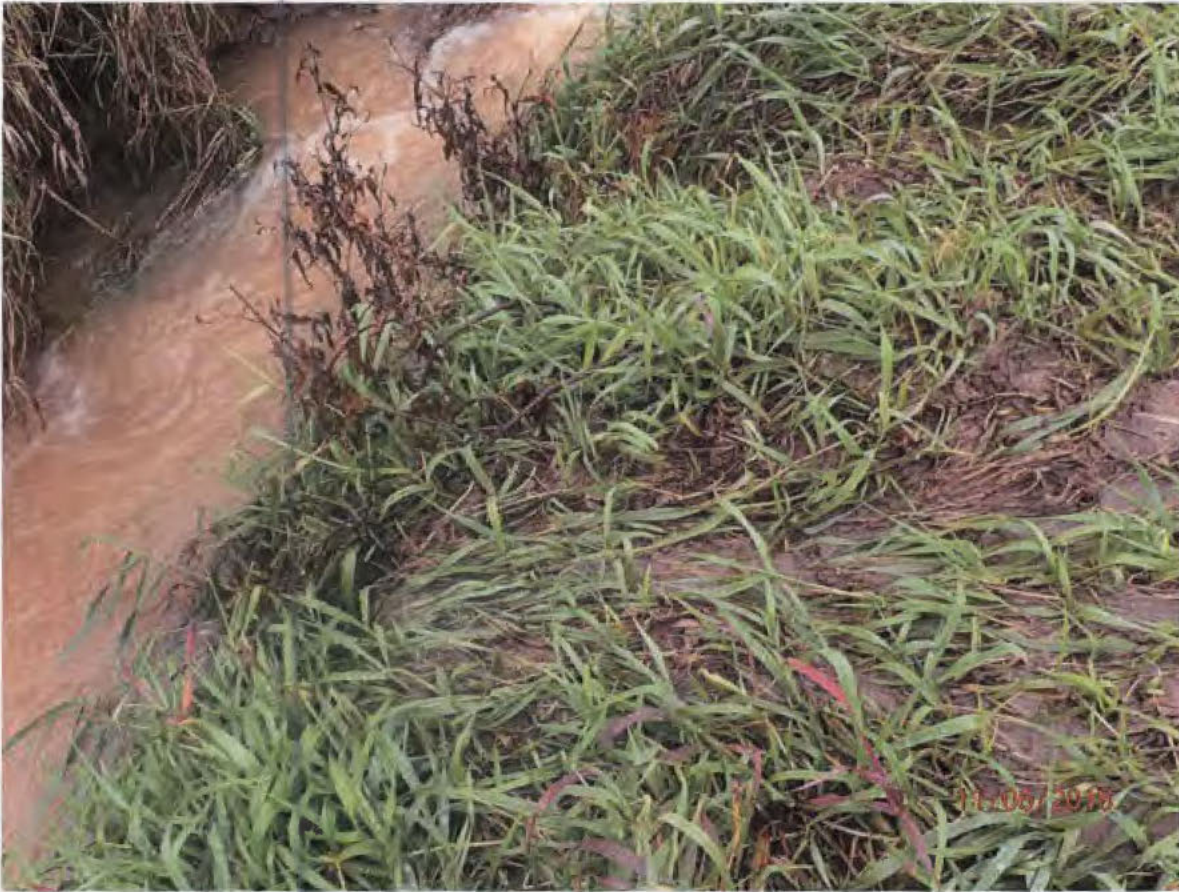
91: PB060095

Description: Flow from feedlot flows into the intermittent unnamed tributary.

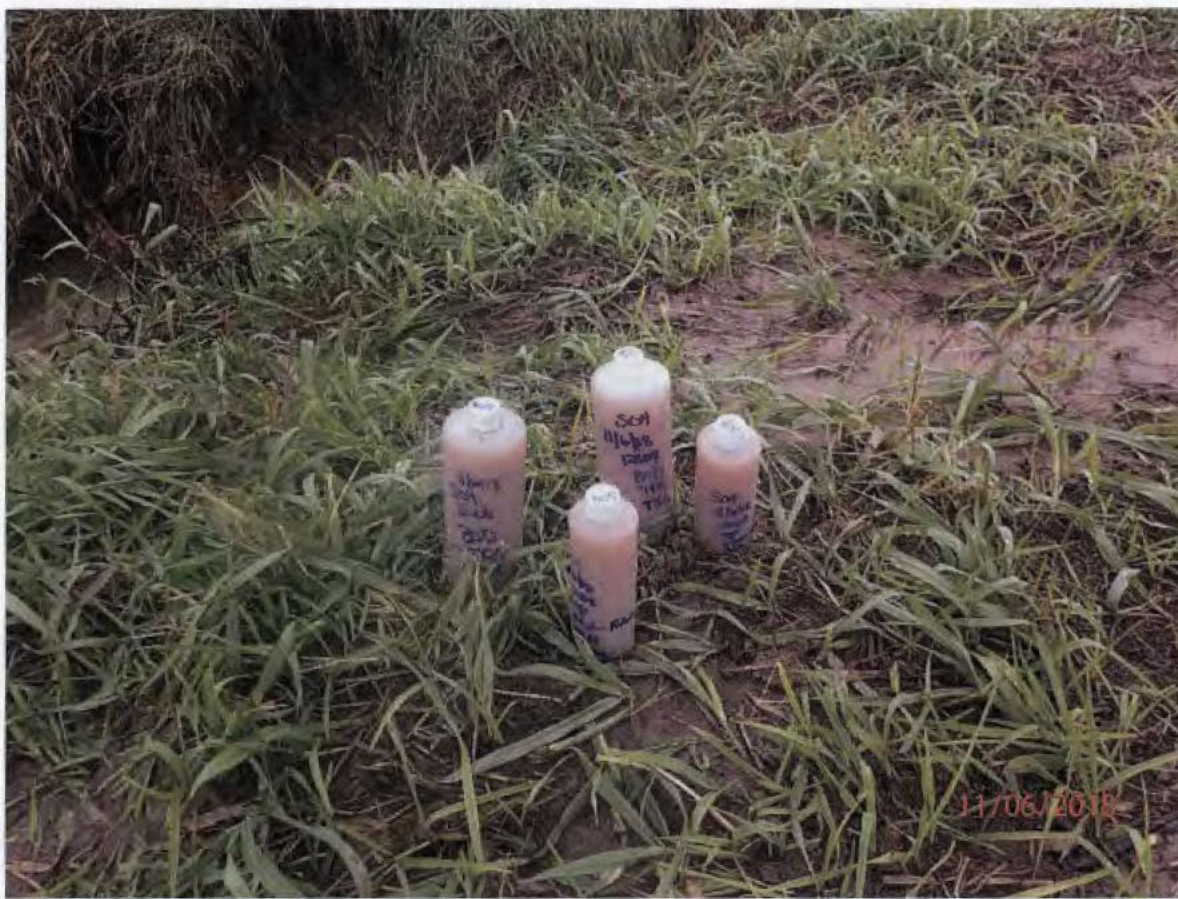
92: PB060097

EPA took a sample (S04) from the discharge pathway at the confluence of this pathway from the Feedlot and the intermittent unnamed tributary.

Description: Sample S04, named "Confluence #2", was taken at 12:08 P.M. from the flow of the discharge pathway from the feedlot into the intermittent unnamed tributary. Split samples were taken for the facility.

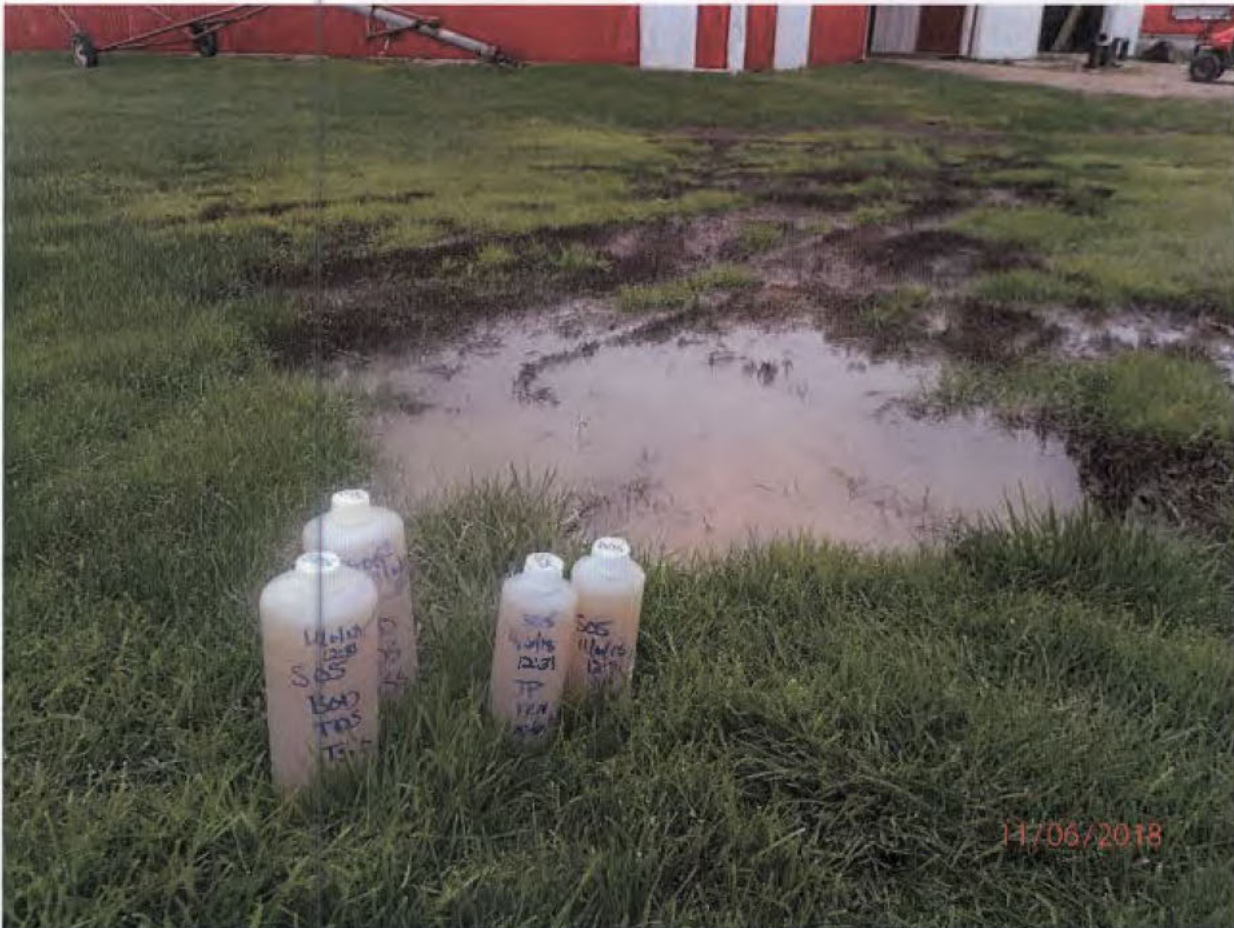
93: PB060098

Description: Sample S05, named "Silage Bag Pathway", was taken at 12:31 P.M. from a pool of liquid in the discharge pathway from the silage bags to the west of the Open Front Heifer Barn. Although this pathway was not observed to flow into the intermittent unnamed tributary on the day of the inspection, with precipitation, this flow has the potential to reach the tributary. This pool of liquid from the silage bags was located before the flow pathway from the silage bags joined the flow pathway from the open pen of the Open Front Heifer Barn. Split samples were taken for the facility.

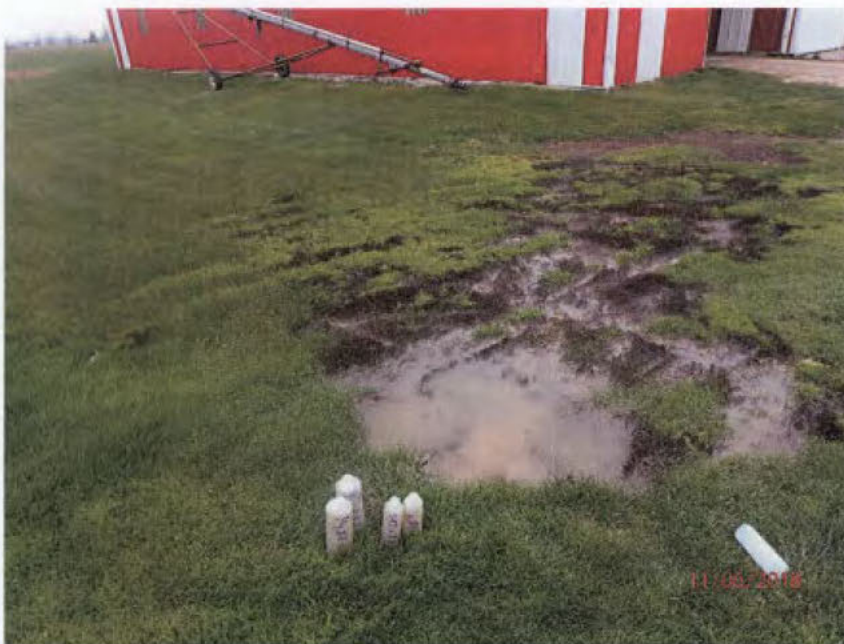
94: PB060099

Description: Overview photo looking downstream at the discharge pathway from sample S05 location.

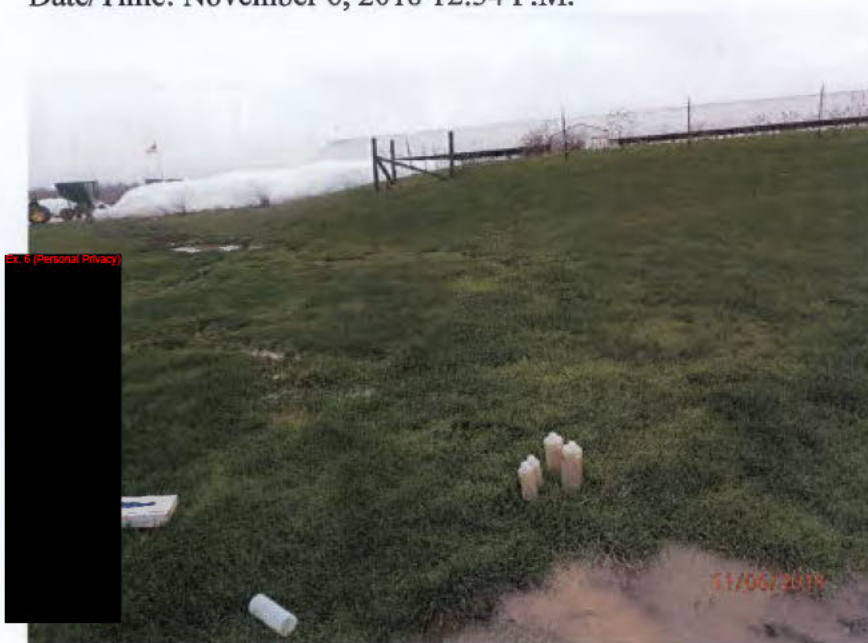
95: PB060100

Description: Overview photo looking upstream at the discharge pathway from sample S05 location.

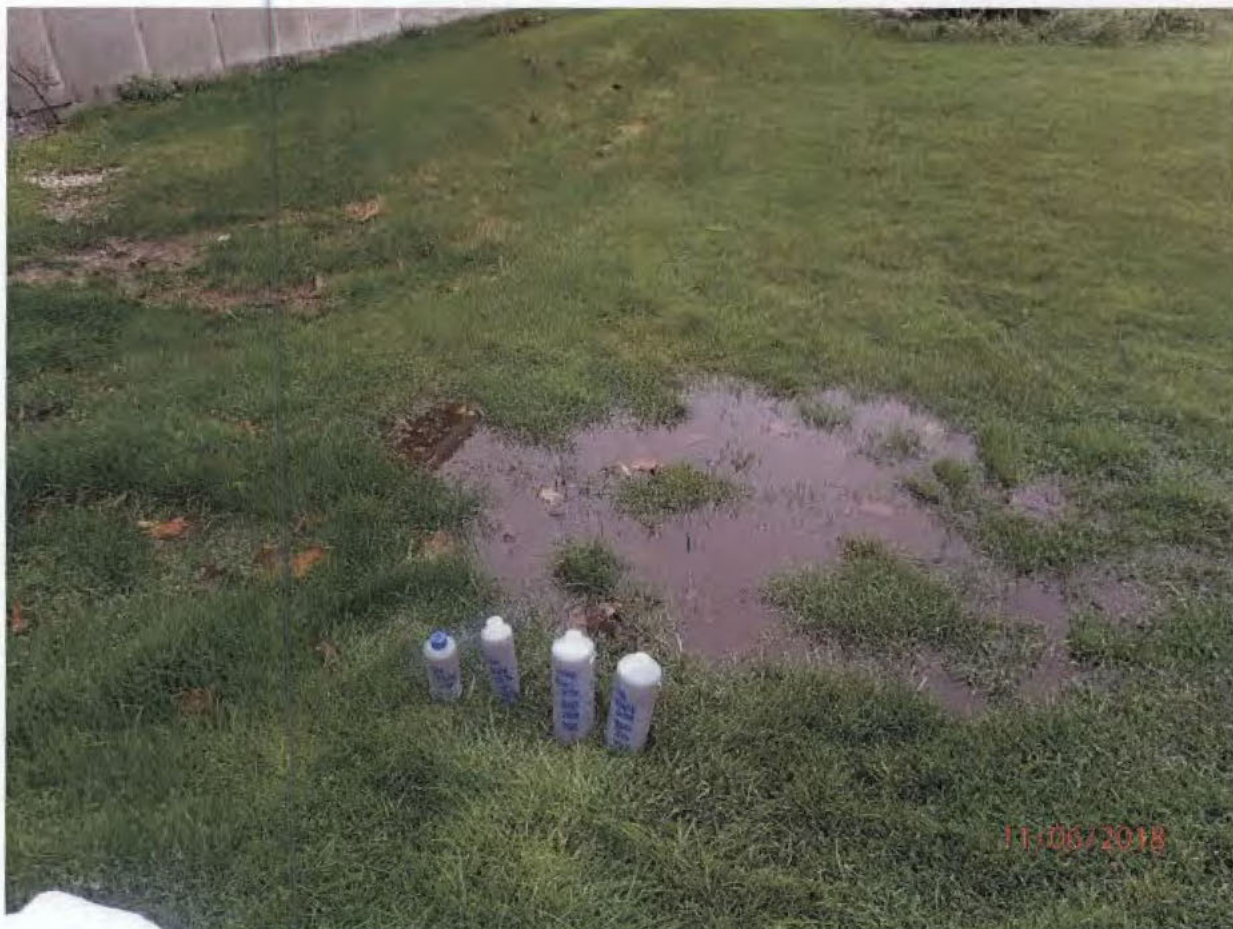
96: PB060101

Description: Sample S06, named "Off Young Stock Pen", was taken at 12:38 P.M. from a pool of liquid in the discharge pathway that flowed from the open pen of the Open Front Heifer Barn. Although this pathway was not observed to flow into the intermittent unnamed tributary on the day of the inspection, with precipitation, this flow has the potential to reach the tributary. This pool of liquid from the open pen of the Open Front Heifer Barn was located before this pathway joined the flow pathway from the silage bags west of the Open Front Heifer Barn. Split samples were taken for the facility.

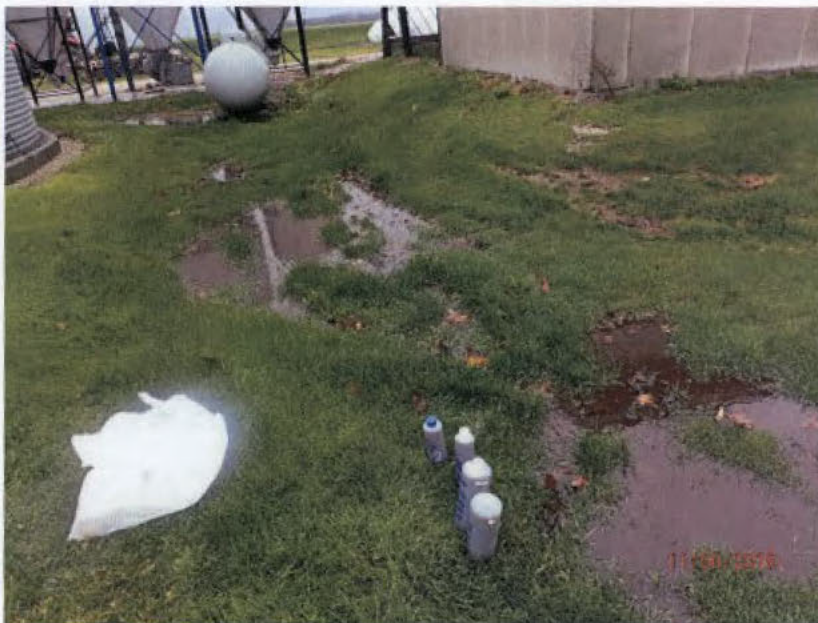
97: PB060102

Description: Overview photo looking upstream at the discharge pathway from the open pen of the Open Front Heifer Barn.
